# WATER QUALITY ISSUES IN THE WISCONSIN RIVER BASIN

## WHAT'S WRONG WITH THE WATER?

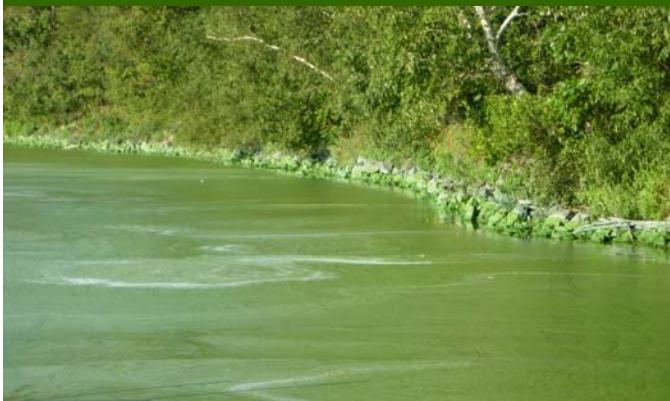
Above: Blue-green algal bloom on the Petenwell Flowage, an impoundment on the Wisconsin River.

**What causes the water to turn bright green?** Excessive nutrients (particularly phosphorus) enter the water from runoff from agricultural fields, barnyards, and residential yards as well as wastewater from industrial and municipal systems (stormwater and treatment plants). These excessive nutrients “fertilize” the water causing algae to grow and spread in the waterway.

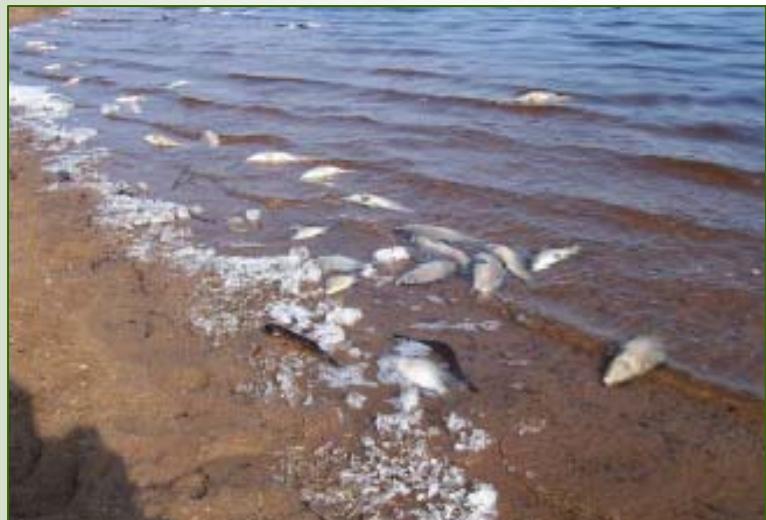
Below: In the winter of 2009, fish lie dead along the shores of the Big Eau Pleine Flowage due to low dissolved oxygen caused by excessive nutrient loading and low water levels.. Fish kills have often occurred in the Petenwell.

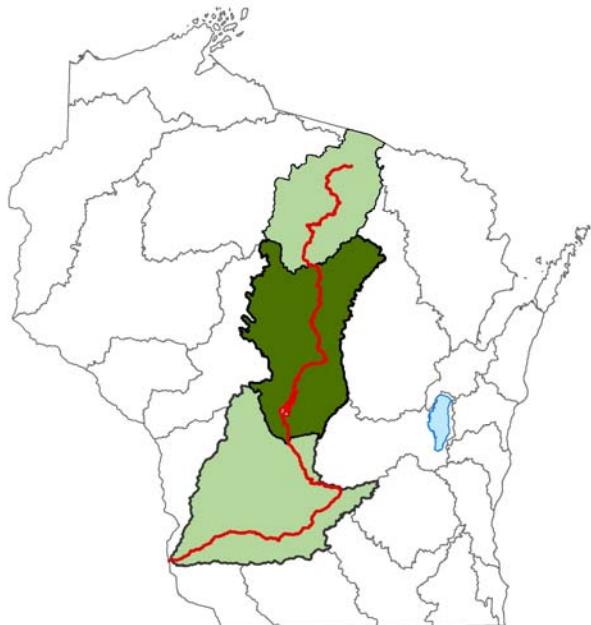
The map above shows the extent of the Wisconsin River Basin. The Central Wisconsin portion from Merrill to Castle Rock is included in the 2009 appropriation and water quality study.
